Report on condition of bench seats in the parish of Brean - 2019

Condition of seats after initial inspection on 12/01/19 and as left condition after remedial work (April 2019)

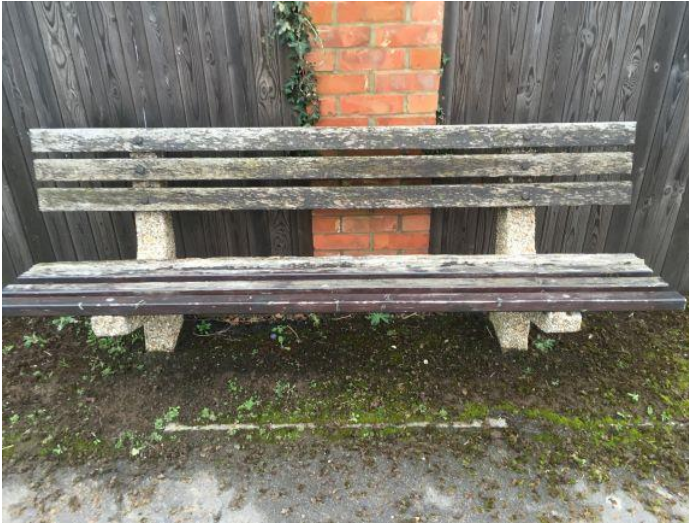
1. Seat at Brean Manor.

Initial condition:- Seat overall is in reasonable condition though 2 slats are showing signs of old age. All wooden slats require rubbing down and painting.

Some slats on benches by Brean manor and Weston turning are showing signs of old age and will require replacement in the next years or two. Concrete of seat opp. leisure centre requires repair.

Suggest that next year one seat has its wooden slats replaced with plastic and any salvageable wooden slats are used on the other bench's. Cost of plastic and fasteners for one bench will be approximately £150, then fitting cost will have to be added.

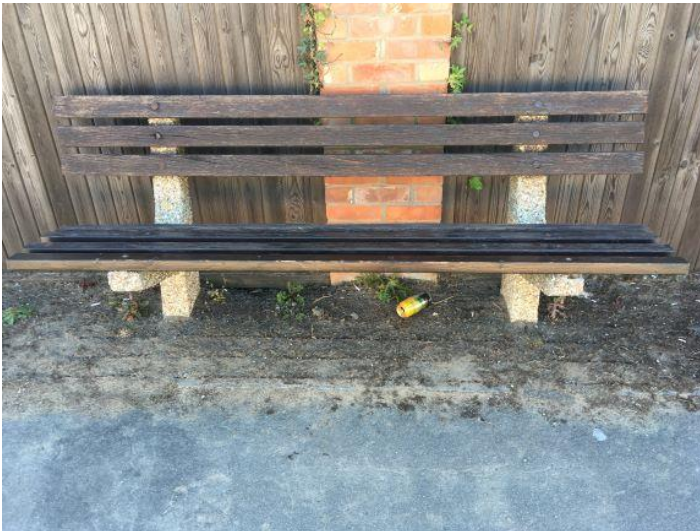
After remedial work:- All wood has been rubbed down and painted.

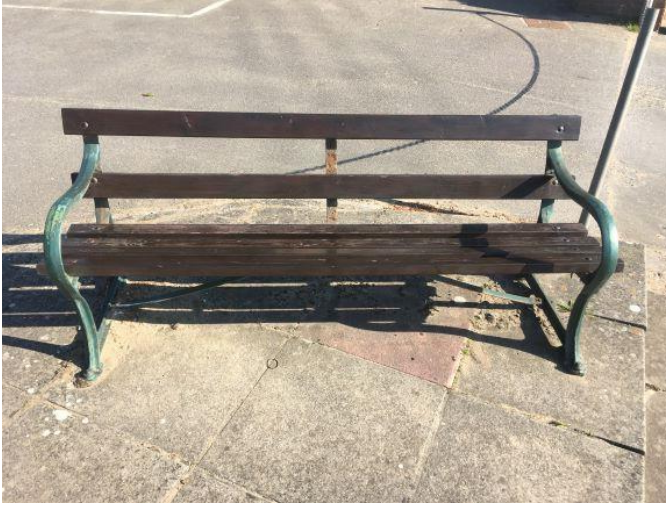
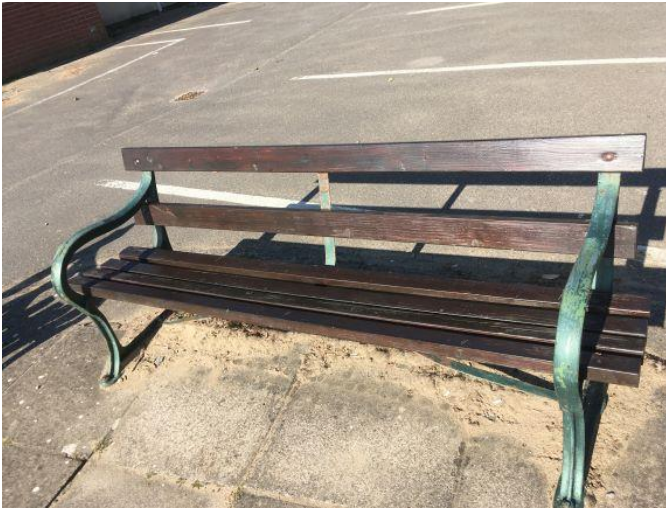
2. 2 metal framed seats by village hall.

Initial condition:- Both seats in good condition.

After remedial work:- All wood has been rubbed down and painted.

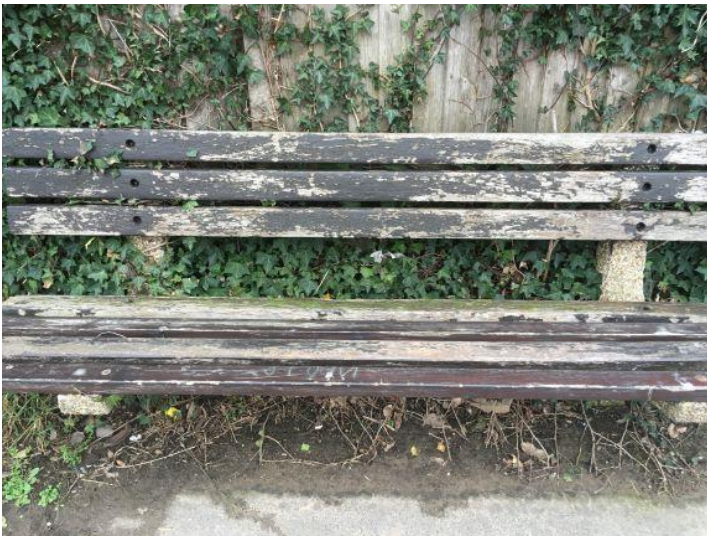
3. Seat at bus stop by Weston turning.

Initial condition:- Seat overall is in reasonable condition. Rear wooden seat slat is loose at one end. All wooden slats require rubbing down and painting.

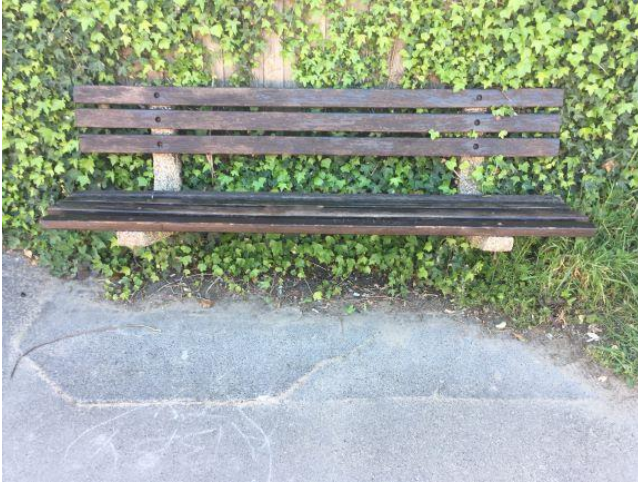
After remedial work:- All wood has been rubbed down and painted.

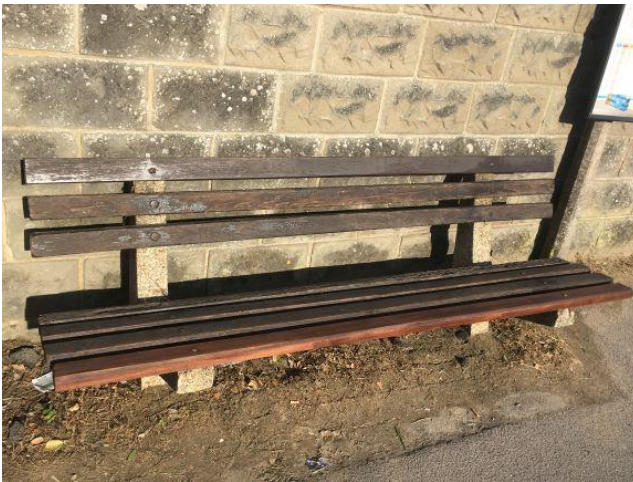
4. Seat at bus stop by Brean garage

Initial Condition:- Seat overall is in reasonable condition. Front wooden seat slat is loose at one end and requires repair / replacement. All wooden slats require rubbing down and painting.

After remedial work:- front wooden slat replaced and all wood rubbed down and painted.

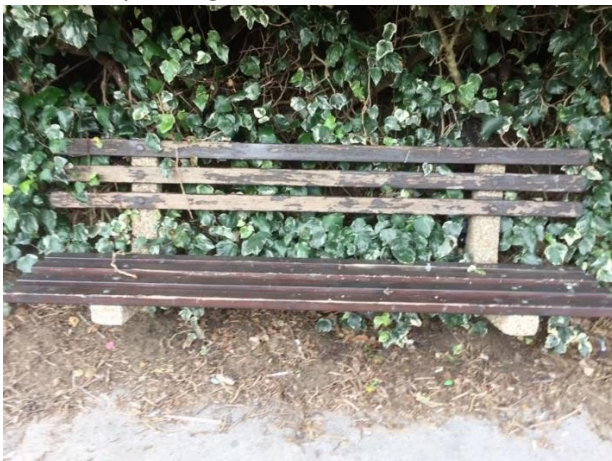
5. Seat by seagull

Initial condition:- Seat overall is in good condition. All wooden slats require light rubbing down and painting.

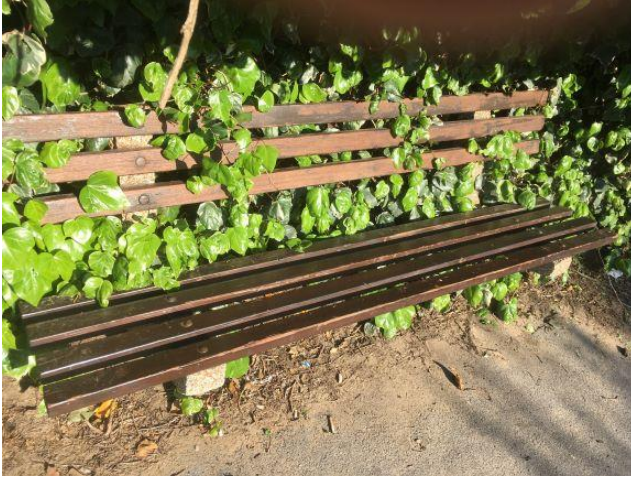
After remedial work:- All wood has been rubbed down and painted.

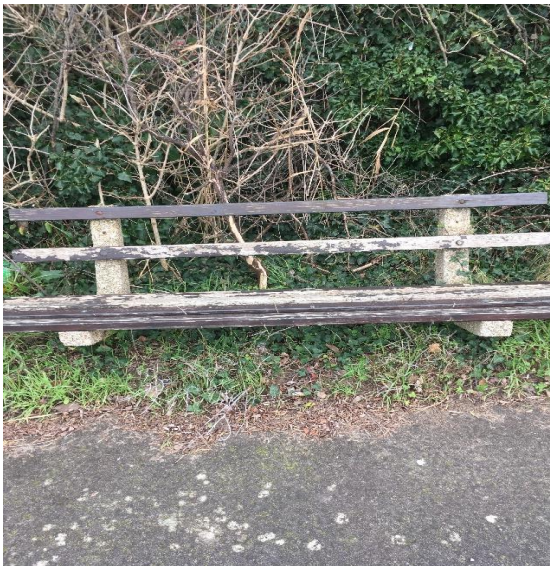
6. Seat by Pontins bus layby but furthest from bus shelter

Initial condition:- Seat overall in reasonable condition. All wooden slats require rubbing down and painting.

1 missing back rest (middle) slate. Requires old fasteners removing from concrete structure (these are rusted in and may not come out, hence bracket may be required) and new carriage bolt fasteners and replacement slate.

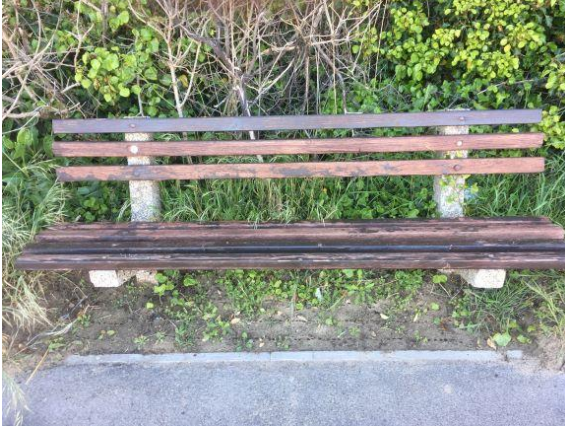
After remedial work:- Back slat replaced and all wood has been rubbed down and painted.

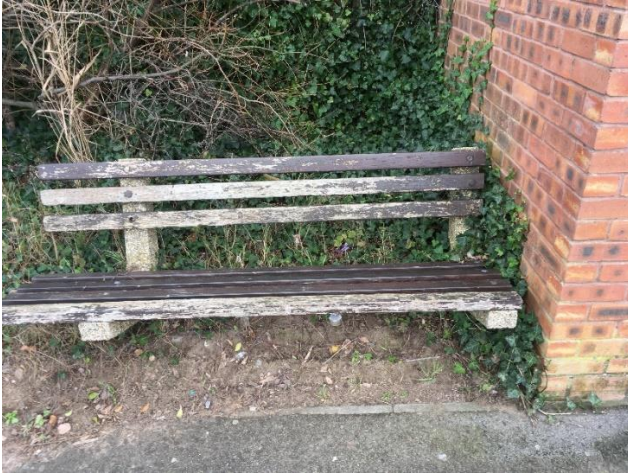
7. Seat at Pontins bus stop / shelter

Initial Condition:- Seat overall in reasonable condition. All wooden slates require rubbing down and painting.

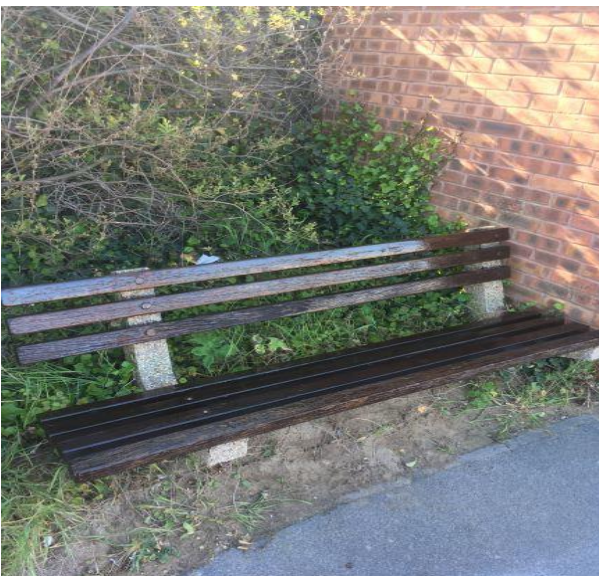
After remedial work:- Still to be done.

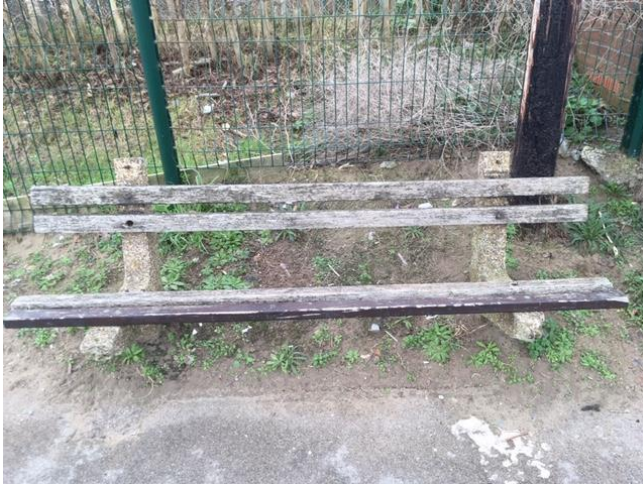
8. Seat by car park / opposite amusements/ leisure centre.

Initial condition:- Seat in poor condition. This is mainly due to the concrete structure deterioration. All wooden slats require rubbing down and painting.

3 missing slats, two from the seat slats (front) and one from the back rest (top). Requires old fasteners removing from concrete structure and new coach bolt fasteners and replacement slats. Note some fasteners rusted and swollen into concrete any may be difficult to remove.

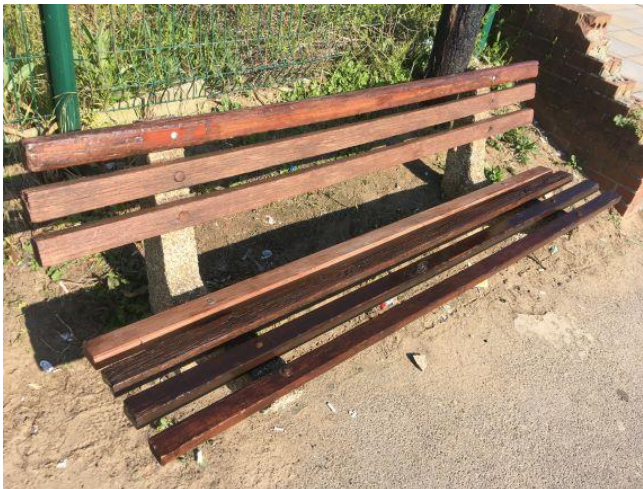
After remedial work:- All wood has been rubbed down and painted.
